Natural Gas Engine-Driven Heat Pump Demonstration at DoD Installations

Performance and Reliability Summary

Final Report

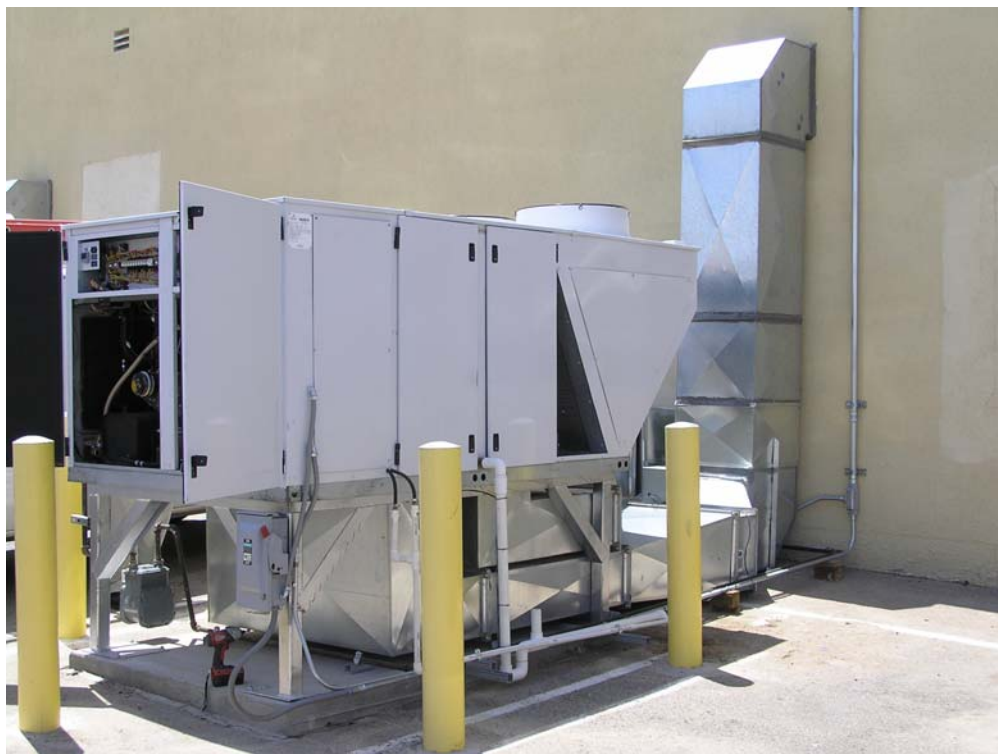
Figure 6. The 10-ton GHP Unit (GHP #17) installed at the fitness center on Marine Corps Logistics Base in Barstow, CA.

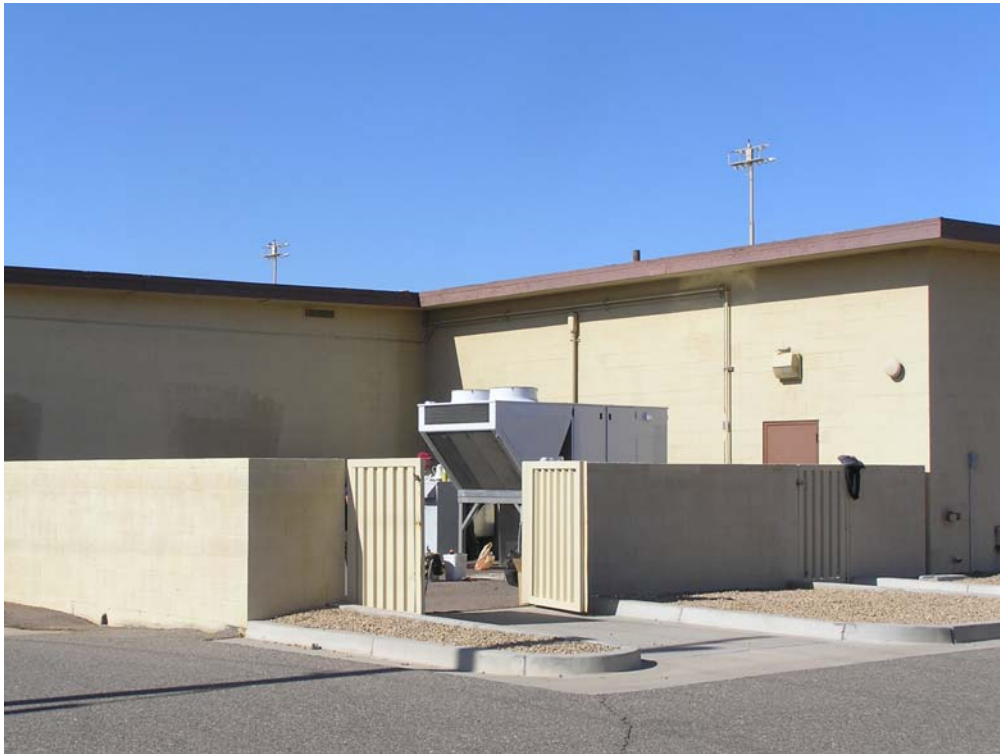
Figure 7. The 10-ton GHP Unit (GHP #18) installed at an office building at Luke AFB, AZ.

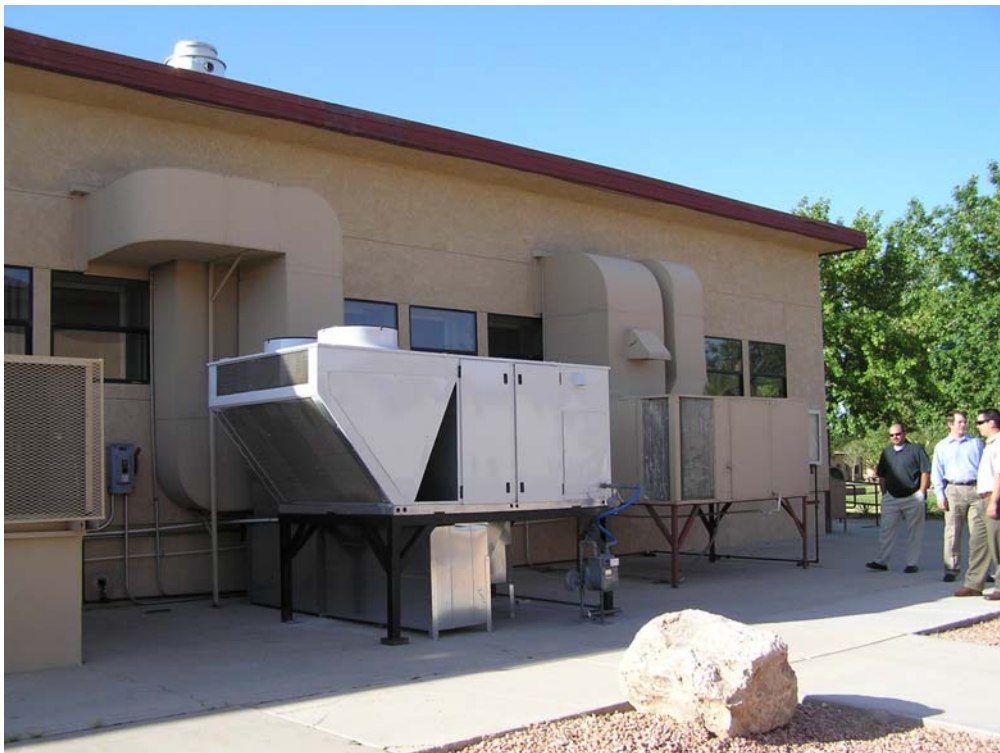
Figure 8. The 10-ton GHP Unit, left (GHP #19) shown side-by-side with a 7.5-ton Electrical DX Unit, right, installed at the dining hall at Nellis AFB, NV.

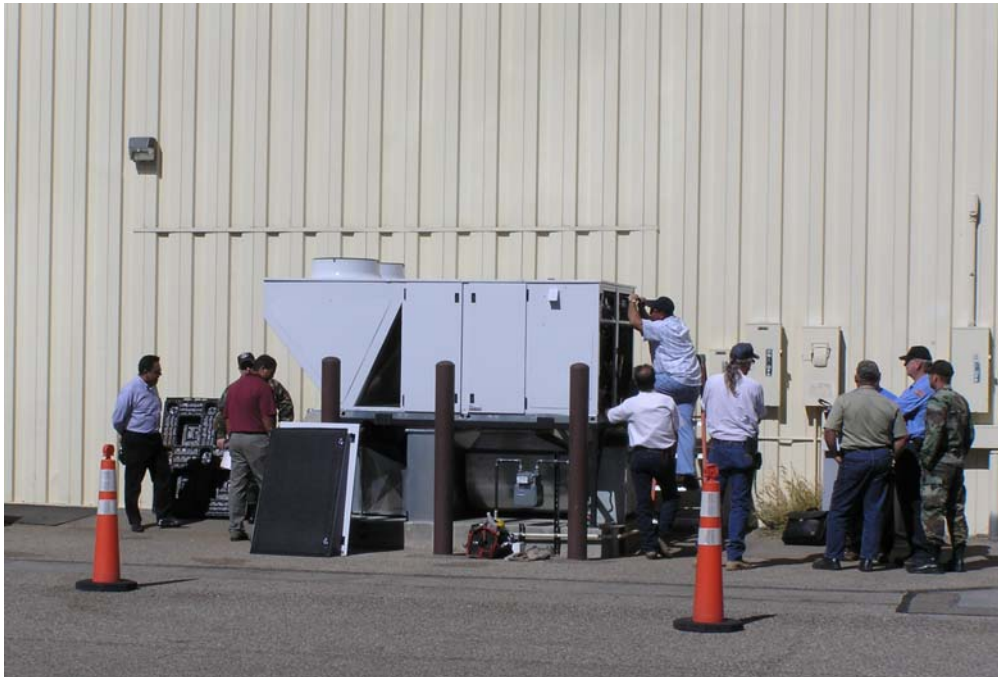
Figure 9. The 10-ton GHP Unit (GHP #20) installed at an office space at Davis-Monthan AFB, AZ.

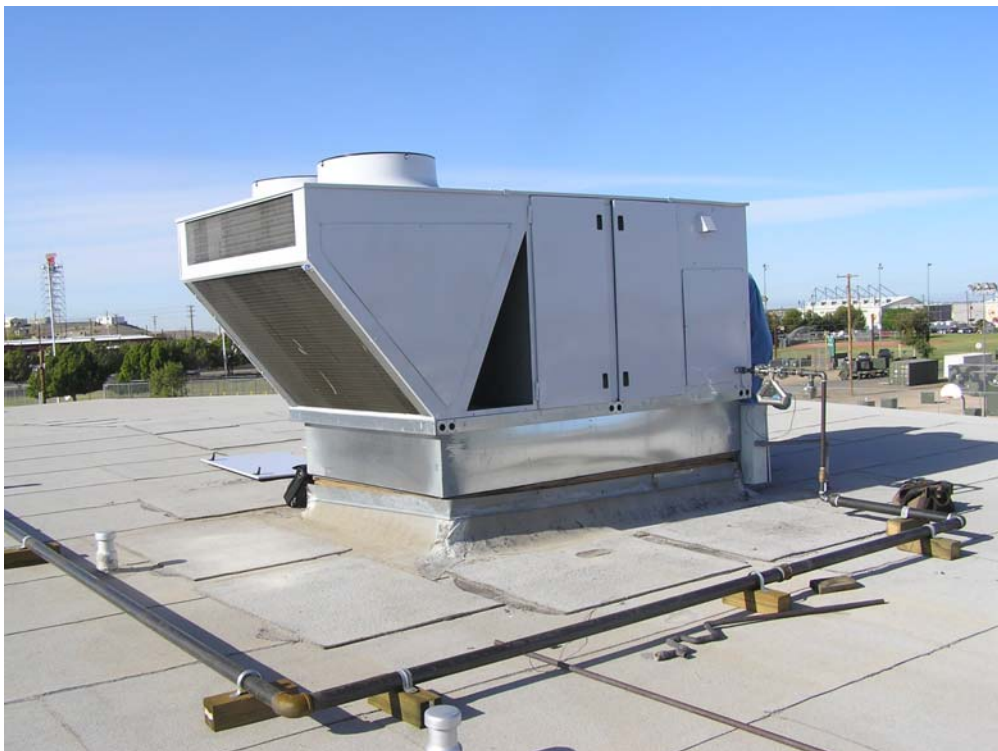
Figure 10. The 10-ton GHP Unit (GHP #21) installed for an office space inside a warehouse at Marine Corps Air Station, Yuma, AZ.

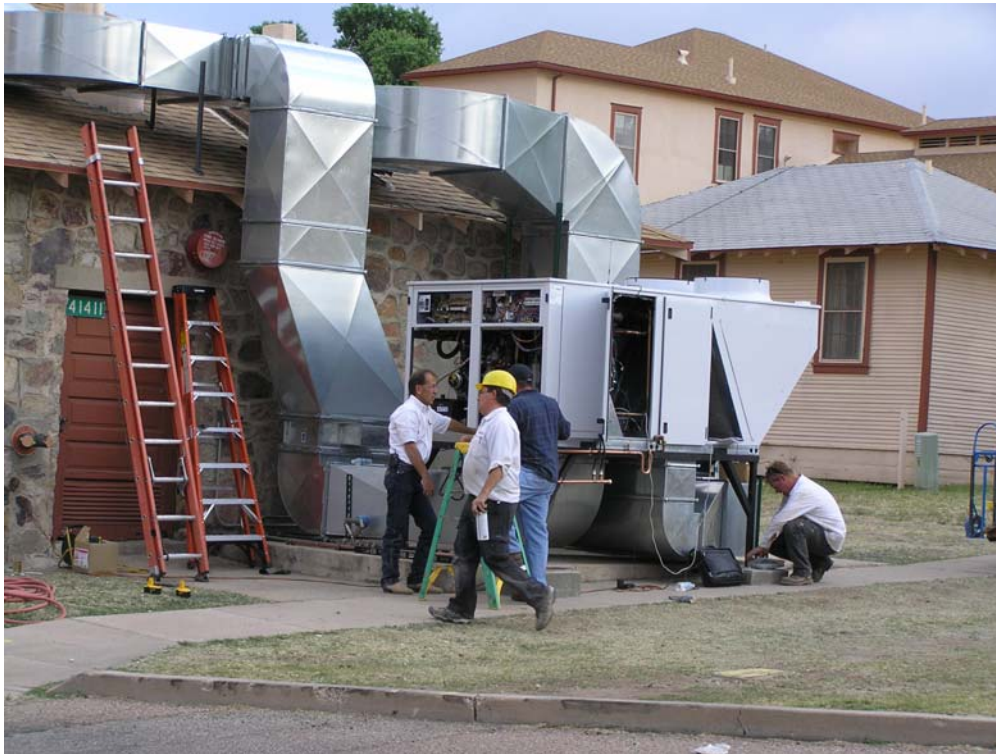
Figure 11. The 10-ton GHP Unit (GHP # 22) installed at the museum at Fort Huachuca AG, AZ.
